**AIRBUS  
TECHNICAL  
DIGEST**

**NUMBER 22  
MARCH 1998**

# HYDRAULIC SYSTEM

## Preventing leaks

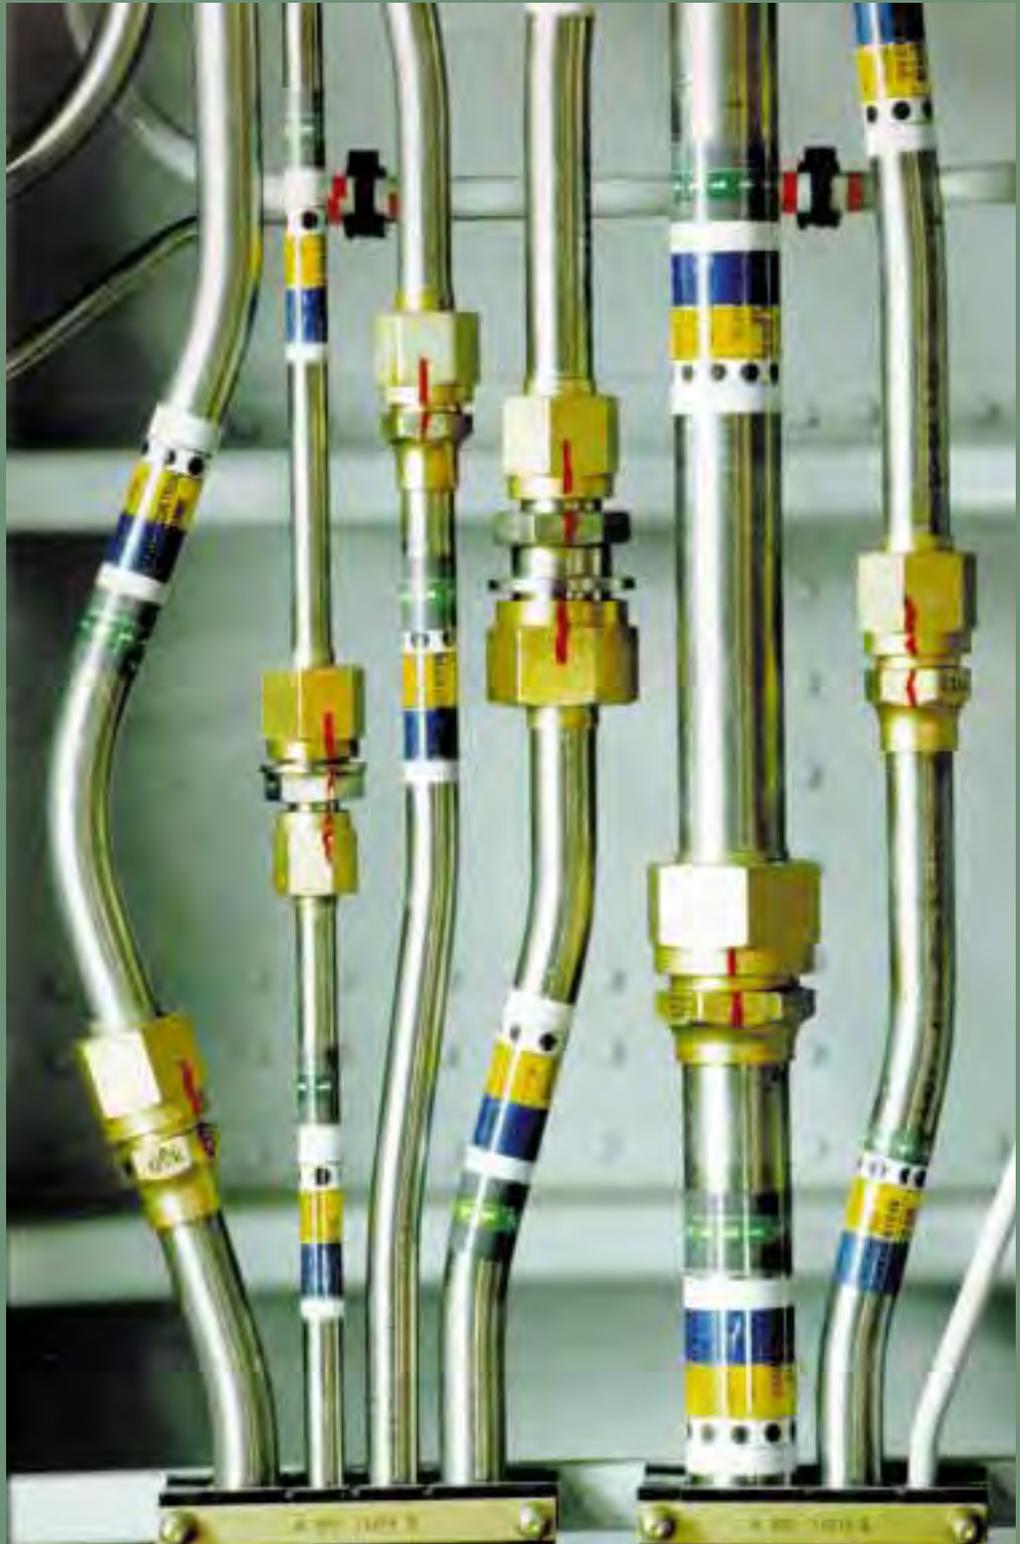
Only the manufacturer can do something about the first two items and Airbus Industrie is continually studying how repetitive defects can be designed out of the system either by changing the design, the supplier and /or the production process (Figure 1).

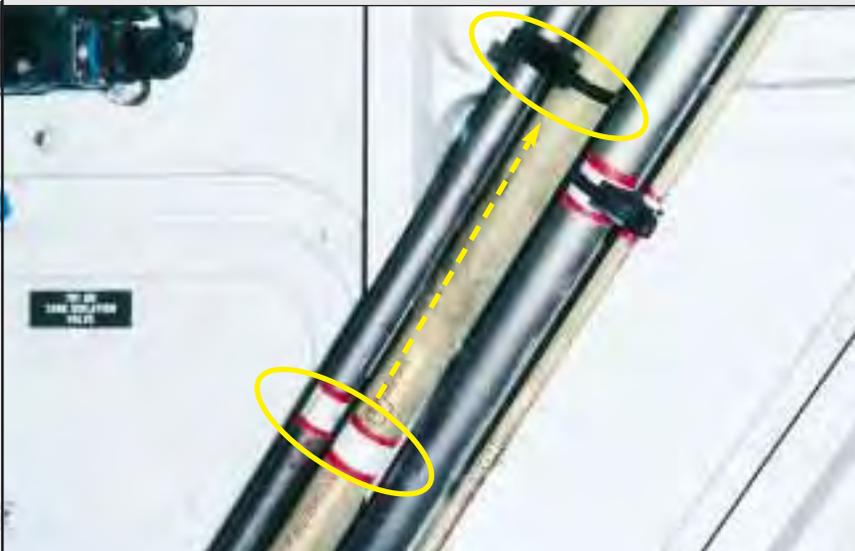
**Figure 4**

Detail of spacer loosening and moving

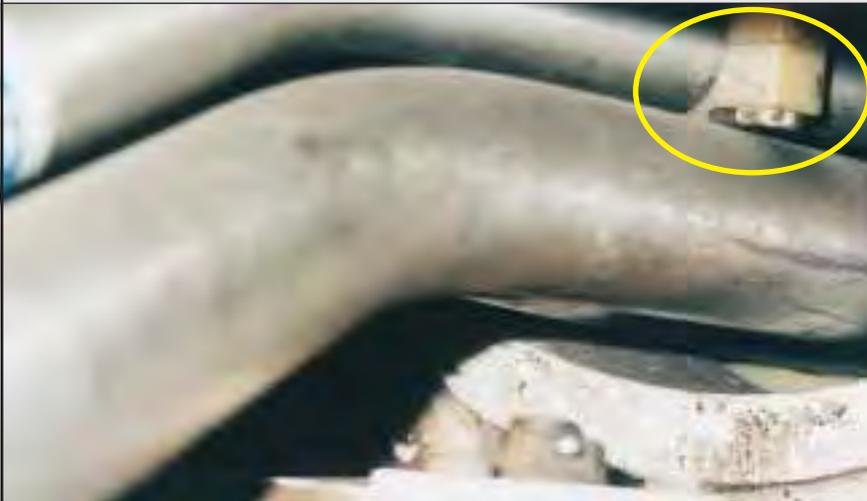
**Figure 7**

Risk of chafing due to small clearance

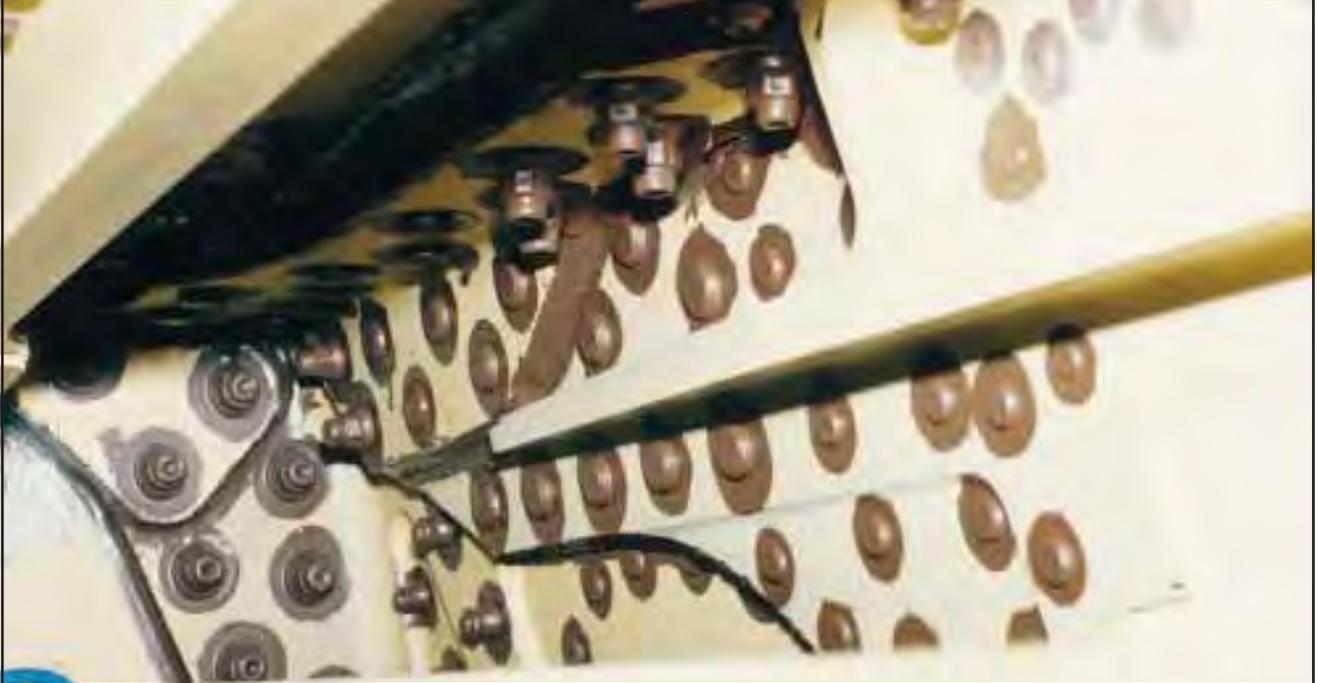
**Figure 1**

Wing structure (typical)

Fuel tanks in modern commercial airliners are housed principally in the wings, and the wing structure is also the fuel tank structure; there are no rubber tanks or other forms of inner walls within the wings. Wing structures are composed of large skin panels, dozens of ribs and stringers, and thousands of bolts and rivets covered with a sealant to prevent fuel seepage (Figure 1). This structure is flexible, as anyone who has flown in turbulent weather will have noticed, as they watch the wing tips moving up and down. Eventually fuel seepage does occur and the leaks become evident on the outer surface of the skin. The visible point of seepage is
